Joseph D. Grant Park
Enhancement Viability of 13 Study Ponds
Hydrology and Habitat Assessment

March 2020

Enhancement Viability of 13 Study Ponds:
Hydrology and Habitat Assessment
Joseph D. Grant County Park
Santa Clara County, California

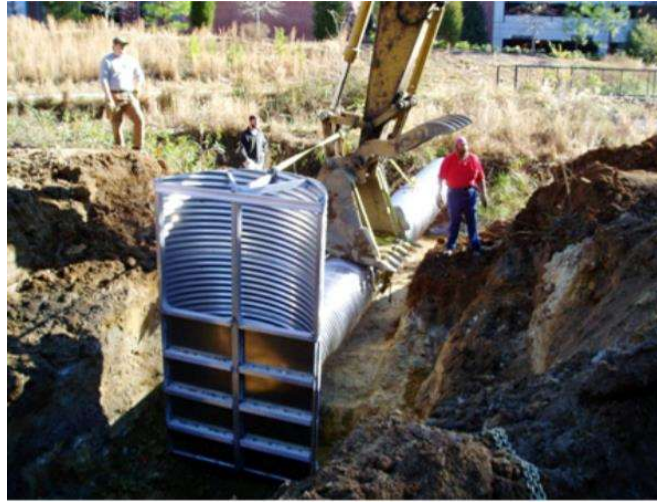
Figure 12. An example of a flashboard-controlled outlet (flashboard not pictured). Water outlet elevation can be controlled via a drain pipe constructed through a berm (NC State 2020).

The adaptive drain method is recommended for Eagle Lake and may also be considered for Kamera Pond, as described in greater detail in Section 6.3.2. See Figures 12, 13, and 14 for examples of components of adaptive drains.

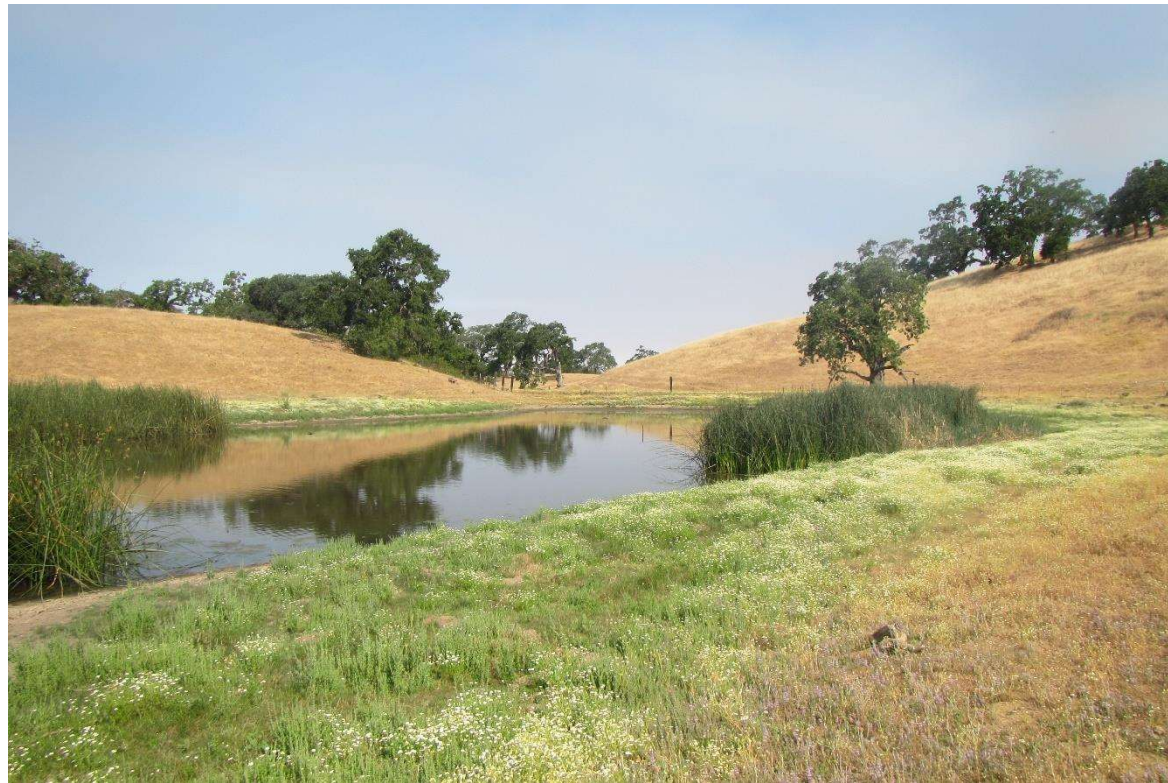
Figure 15. Representative Photo and Modeled Hydrology for Eagle Lake

Eagle Lake, July 2, 2018 (Balance Hydrologics)

**Modeled
 Inundation
 under
 Existing
 Conditions**

A representative photo and the modeled hydrology for Eagle Lake are illustrated in Figure 15.

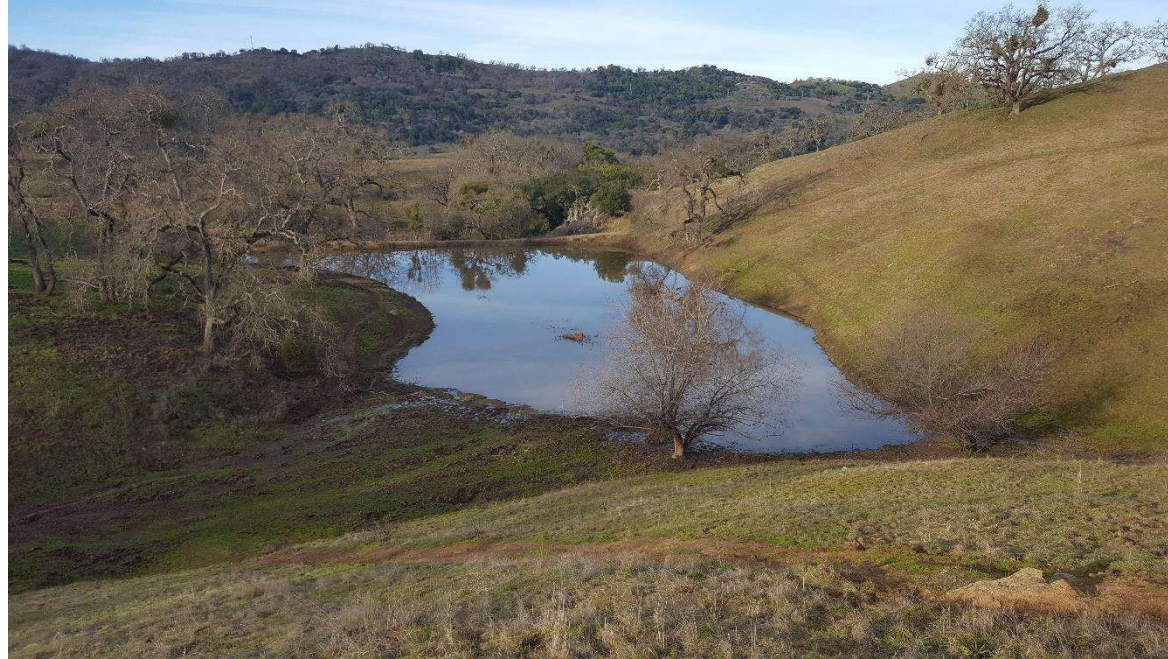
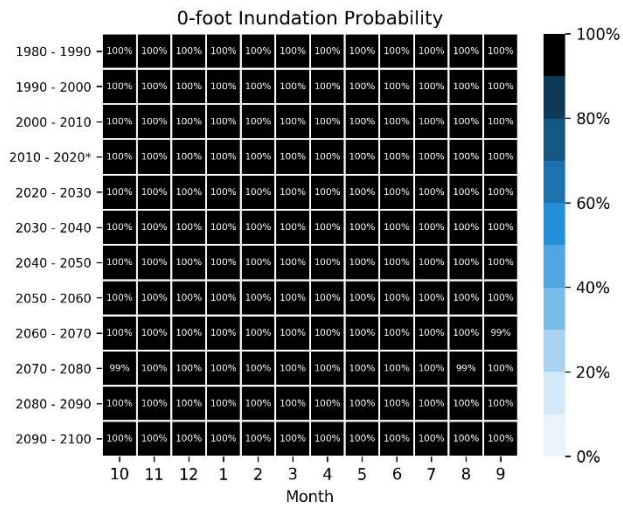
Figure 16. Representative Photo and Modeled Hydrology for Bass Lake

Bass Lake, January 30, 2017 (Balance Hydrologics)

**Modeled
 Inundation
 under
 Existing
 Conditions**

A representative photo and the modeled hydrology for Bass Lake is illustrated in Figure 16.

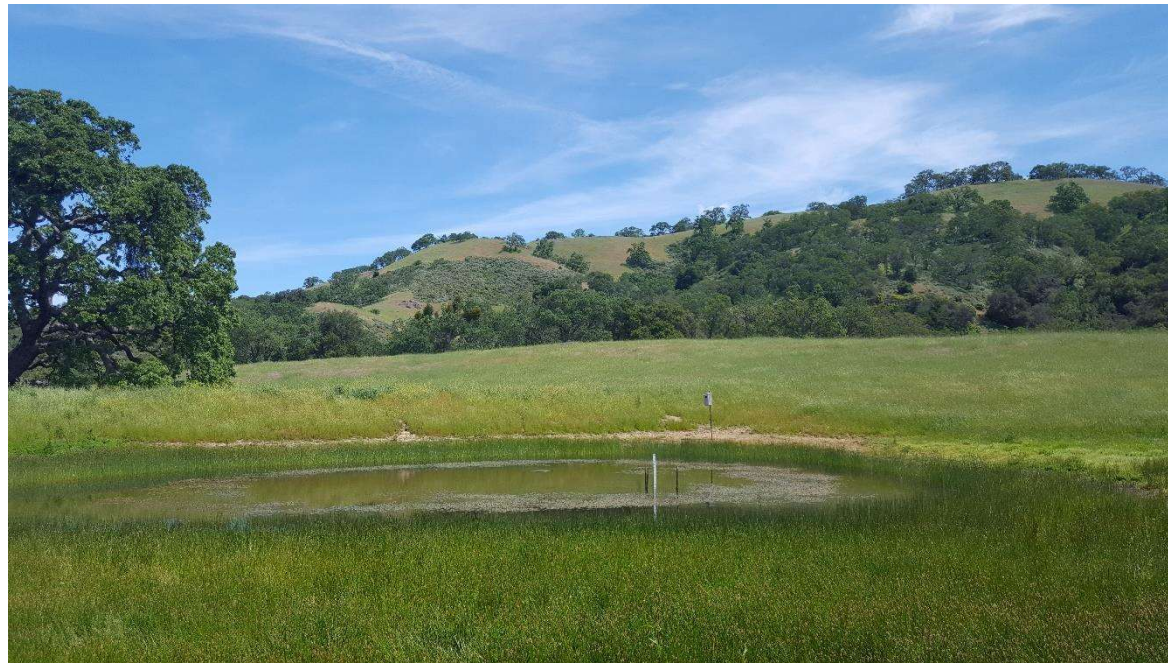
Figure 17. Representative Photo and Modeled Hydrology for Hotel Pond

Hotel Pond, May 10, 2017 (Balance Hydrologics)

**Modeled
 Inundation
 under
 Existing
 Conditions**

A representative photo and the modeled hydrology for Hotel Pond is illustrated in Figure 17.

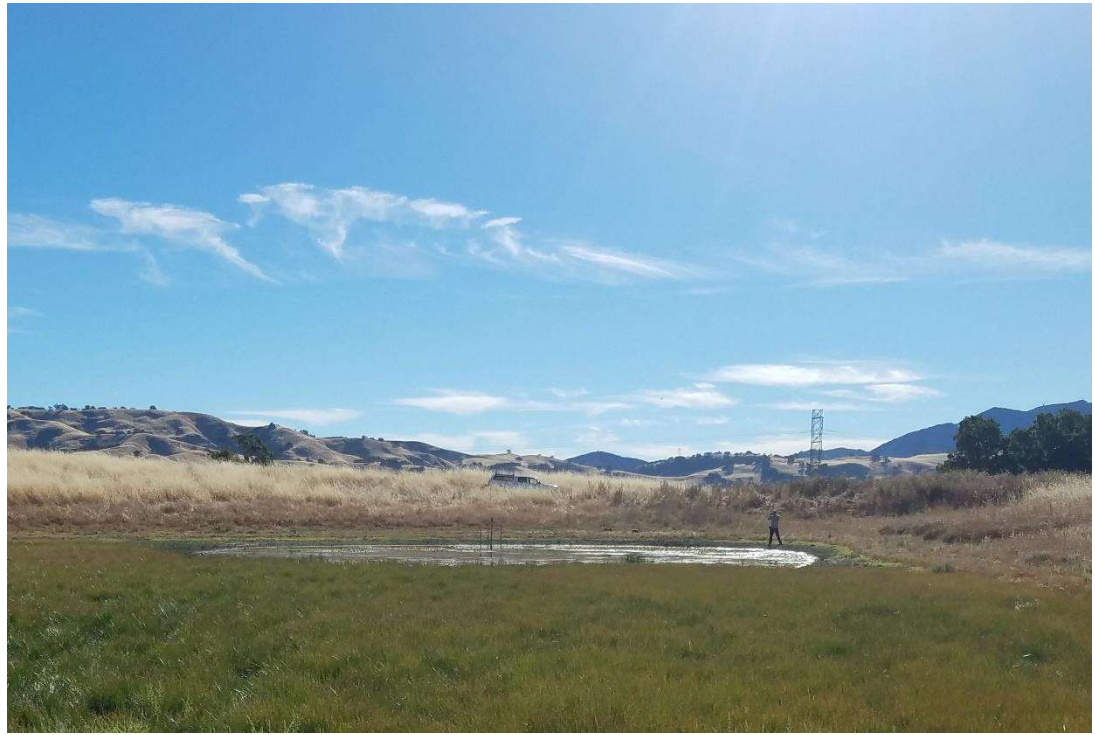
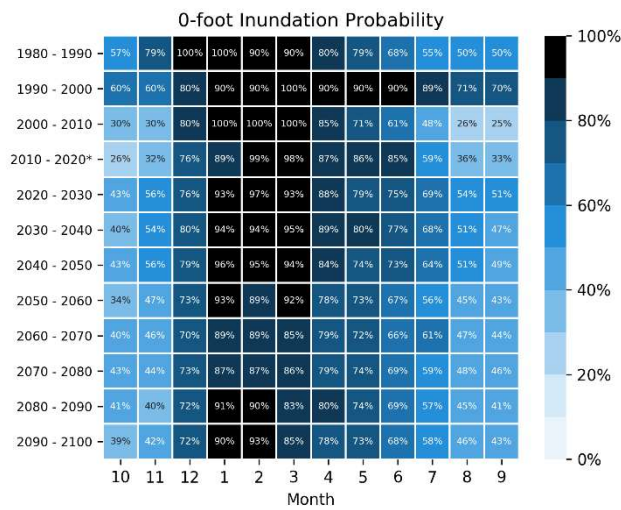
Figure 18. Representative Photo and Modeled Hydrology for Edwards Ponds

Edwards Pond, June 27, 2018 (Balance Hydrologics)

**Modeled
 Inundation
 under
 Existing
 Conditions**

A representative photo and the modeled hydrology for Edwards Pond are illustrated in Figure 18.

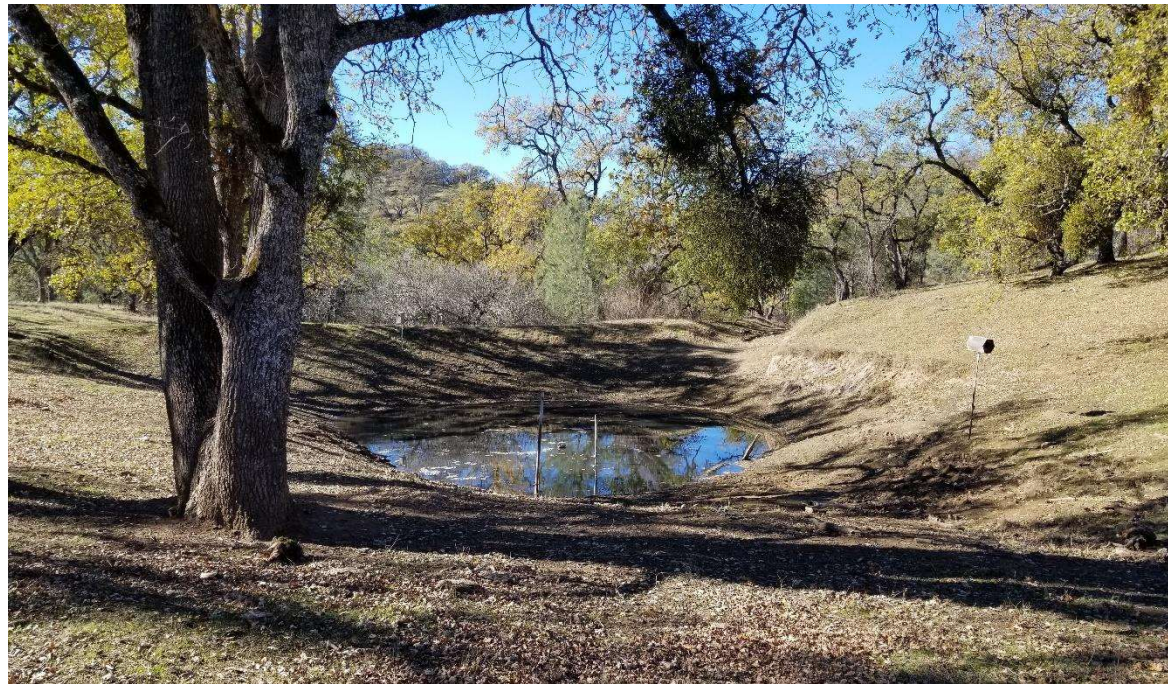
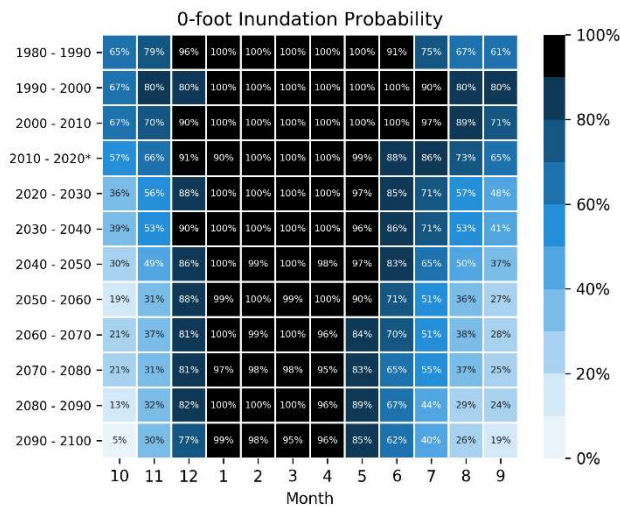
Figure 19. Representative Photo and Modeled Hydrology for Valentine I

Valentine Pond, October 20, 2017 (Balance Hydrologics)

**Modeled
 Inundation
 under
 Existing
 Conditions**

A representative photo and the modeled hydrology for Valentine Pond is illustrated in Figure 19.

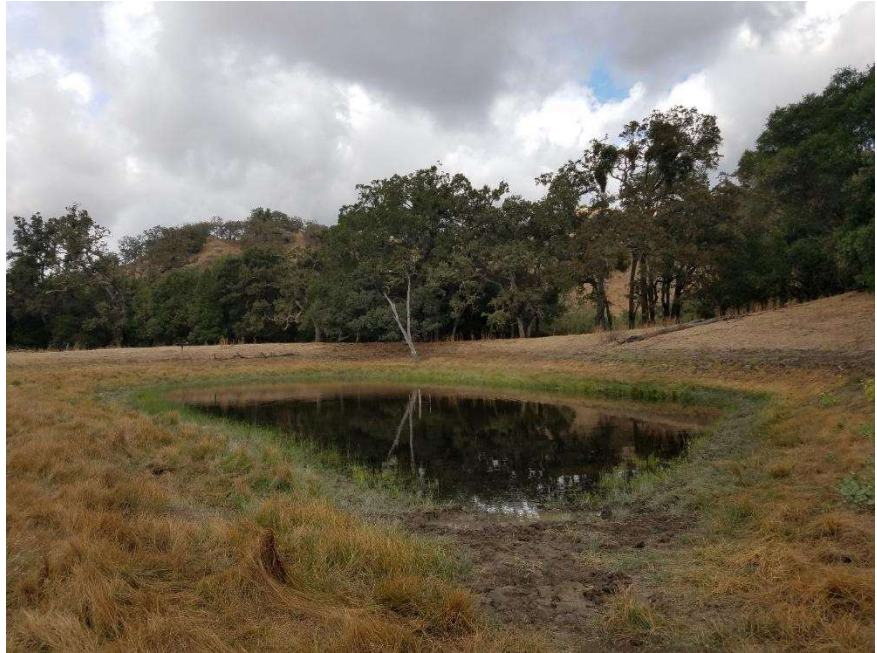
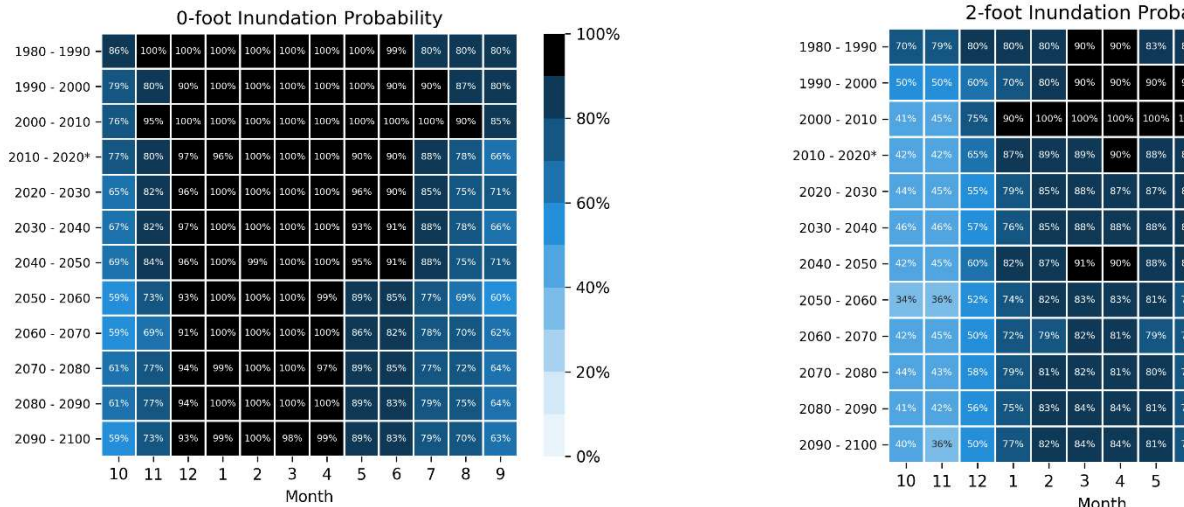
Figure 20. Representative Photo and Modeled Hydrology for Kamera Pond

Kamera Pond, October 20, 2017 (Balance Hydrologics)

Modeled Inundation under Existing Conditions

A representative photo and the modeled hydrology for Kamera Pond are illustrated in Figure 20.

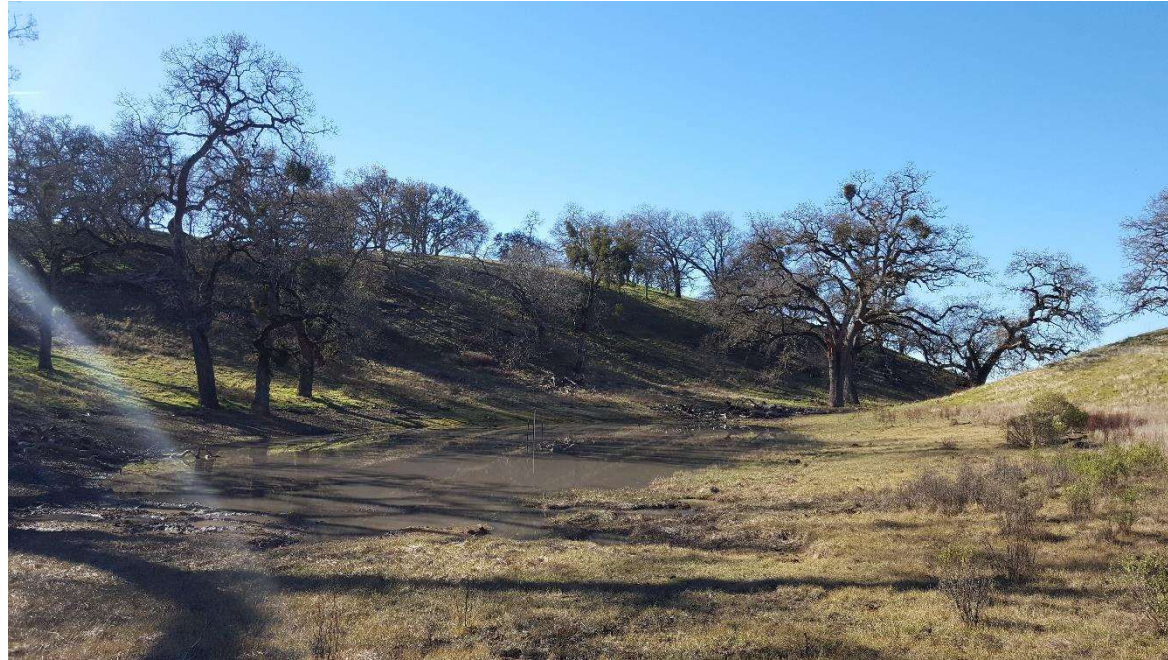
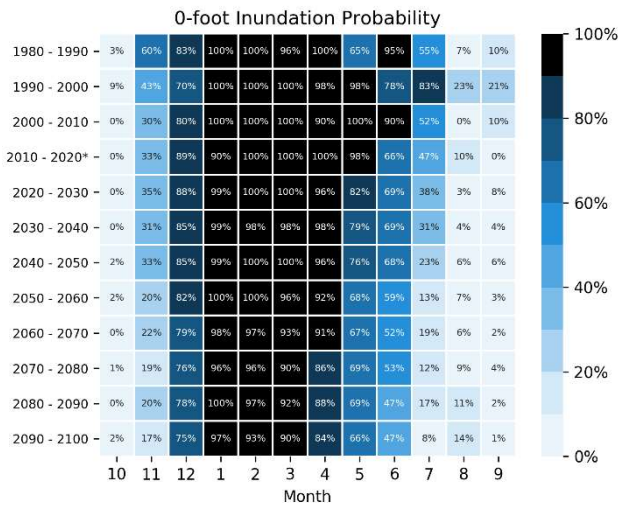
Figure 21. Representative Photo and Modeled Hydrology for Deer Valley

Deer Valley Pond, December 29, 2016 (Balance Hydrologics)

**Modeled
 Inundation
 under
 Existing
 Conditions**

A representative photo and the modeled hydrology for Deer Valley Pond is illustrated in Figure 21.

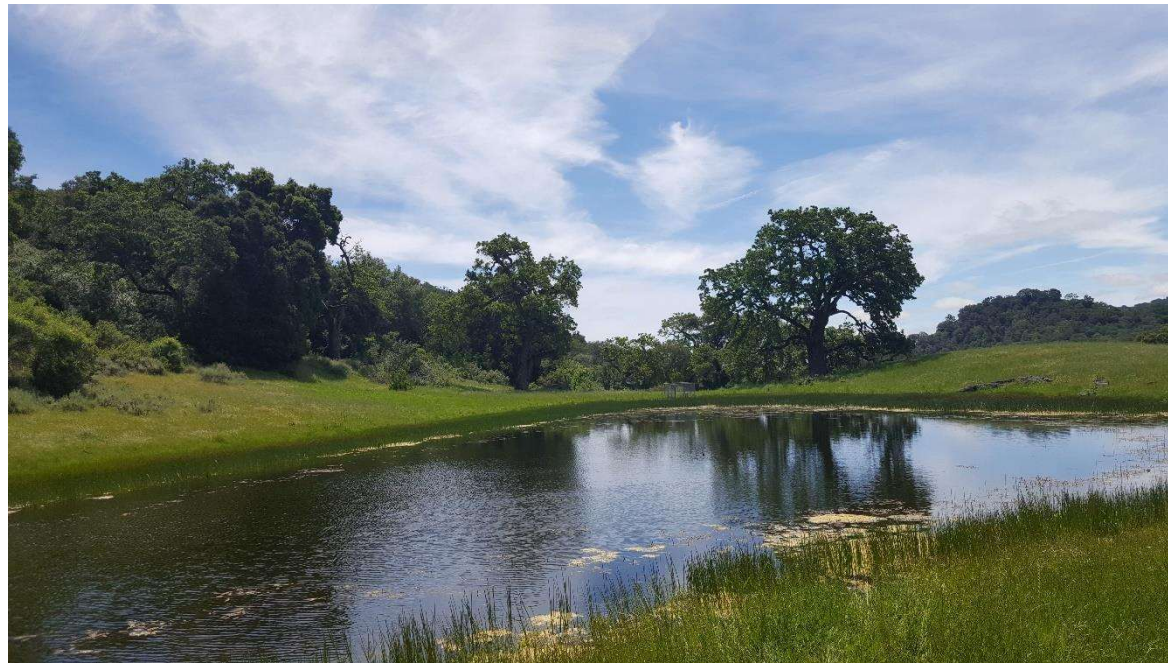
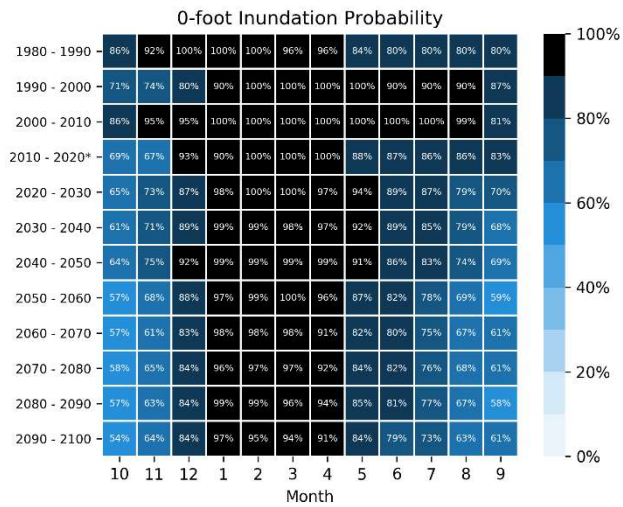
Figure 22. Representative Photo and Modeled Hydrology for Rattlesnake

Rattlesnake Pond, May 10, 2017 (Balance Hydrologics)

**Modeled
 Inundation
 under
 Existing
 Conditions**

A representative photo and the modeled hydrology for Rattlesnake Pond is illustrated in Figure 22.

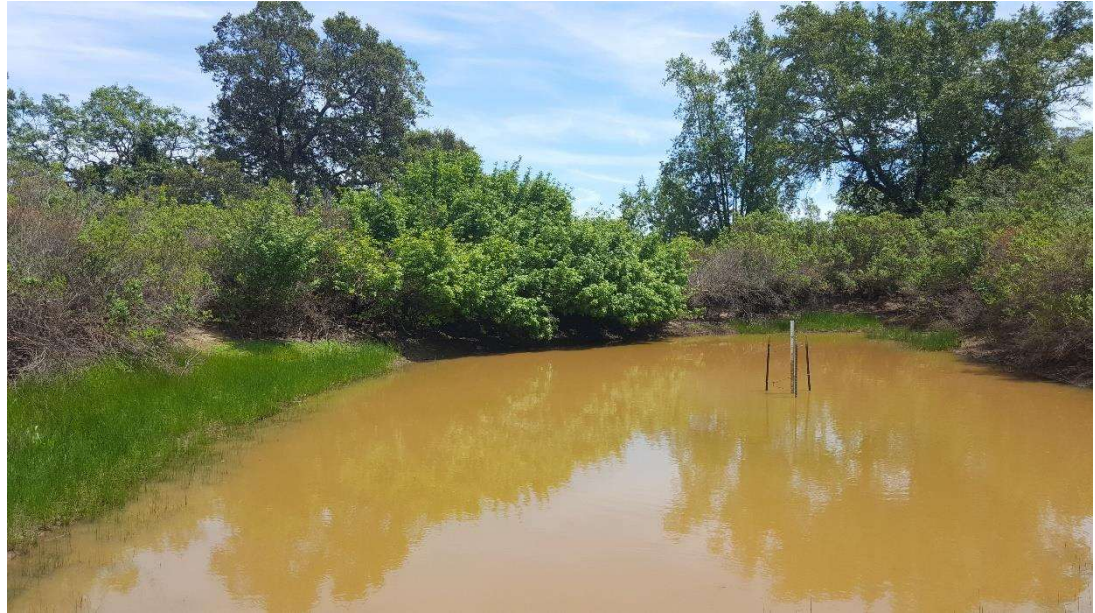
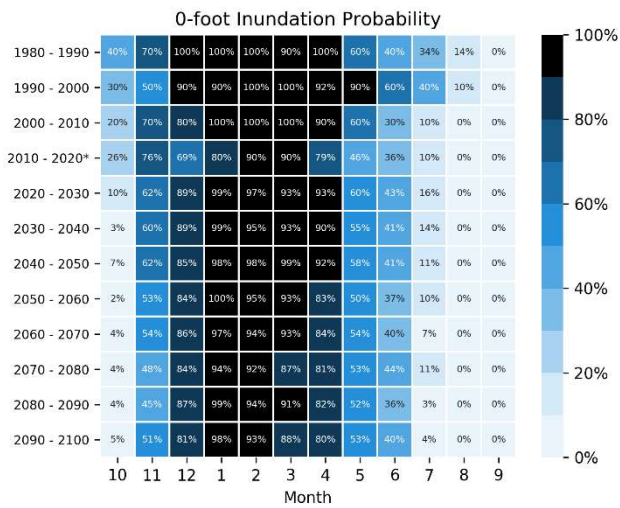
Figure 23. Representative Photo and Modeled Hydrology for Dairy Pond

Dairy Pond, May 10, 2017 (Balance Hydrologics)

**Modeled
 Inundation
 under
 Existing
 Conditions**

A representative photo and the modeled hydrology for Dairy Pond is illustrated in Figure 23.

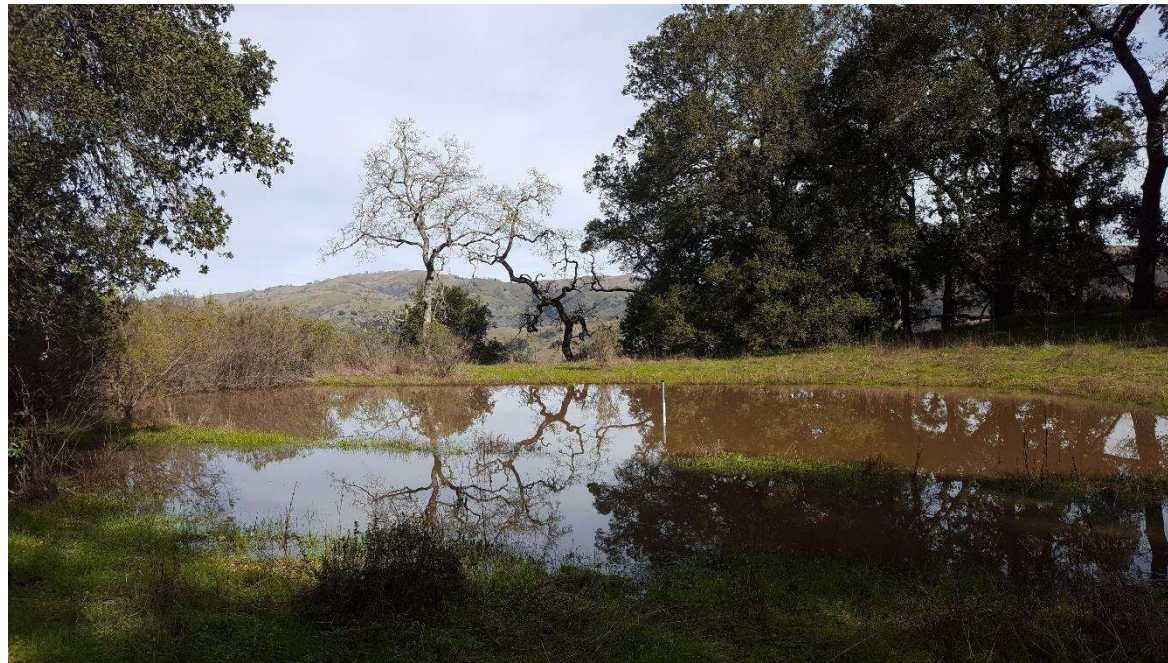
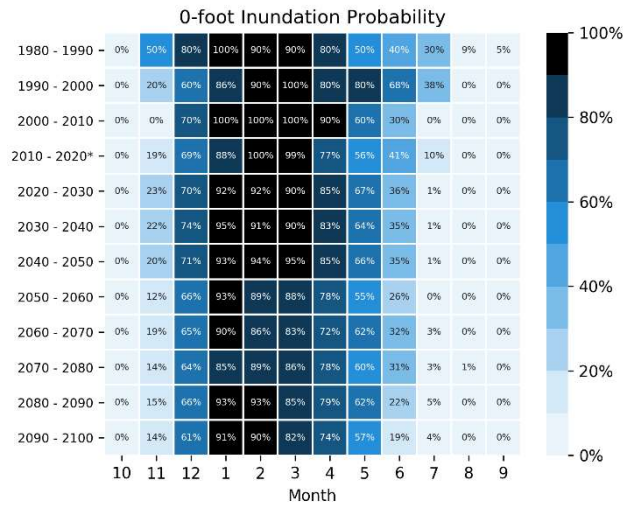
Figure 24. Representative Photo and Modeled Hydrology for Brush Pond

Brush Pond, January 30, 2017 (Balance Hydrologics)

**Modeled
 Inundation
 under
 Existing
 Conditions**

A representative photo and the modeled hydrology for Brush Pond is illustrated in Figure 24.

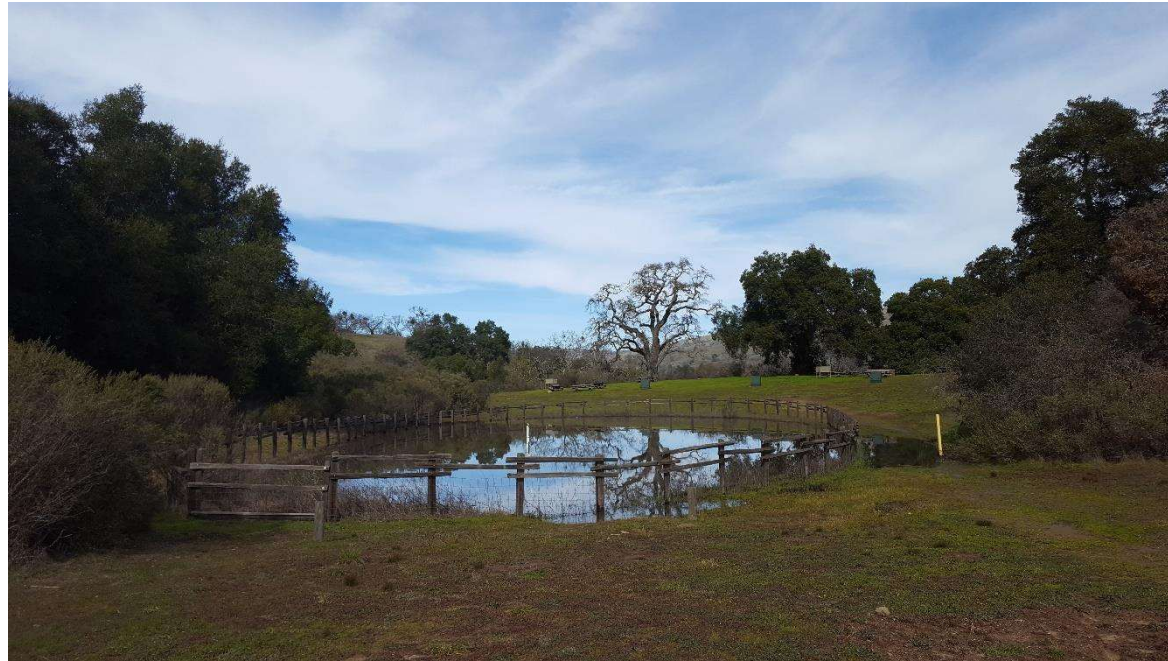
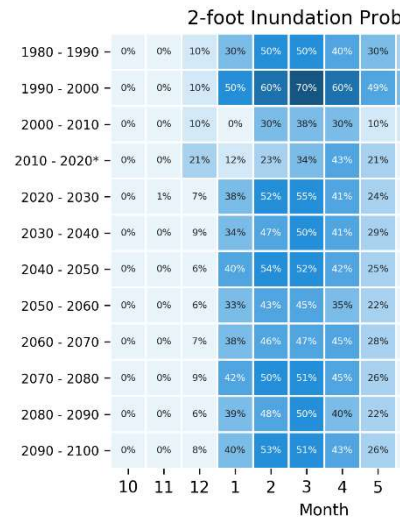
Figure 25. Representative Photo and Modeled Hydrology for Woodland

Woodland Pond, January 30, 2017 (Balance Hydrologics)

**Modeled
 Inundation
 under
 Existing
 Conditions**

A representative photo and the modeled hydrology for Woodland Pond are illustrated in Figure 25.

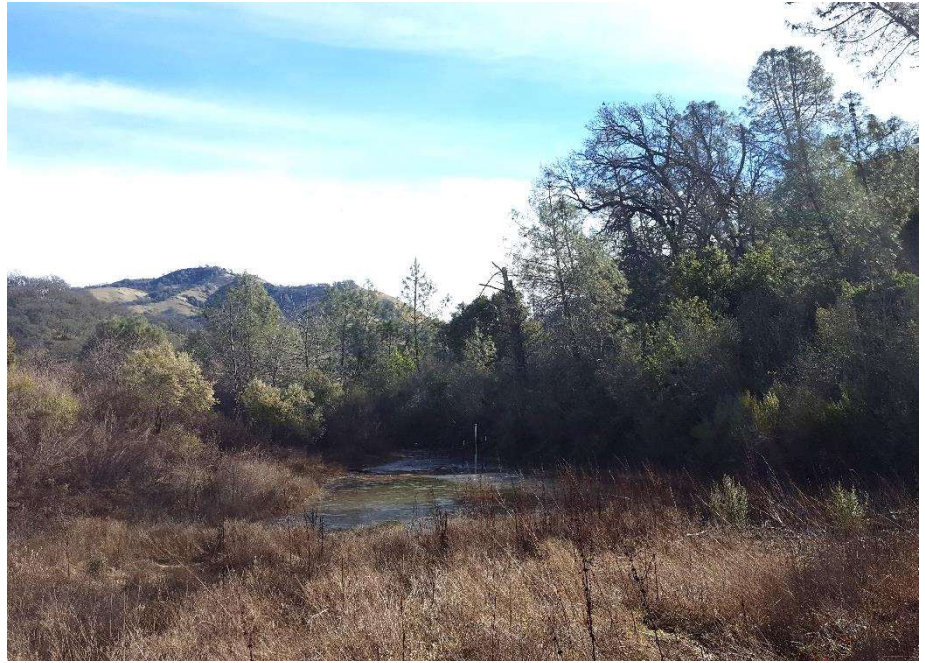
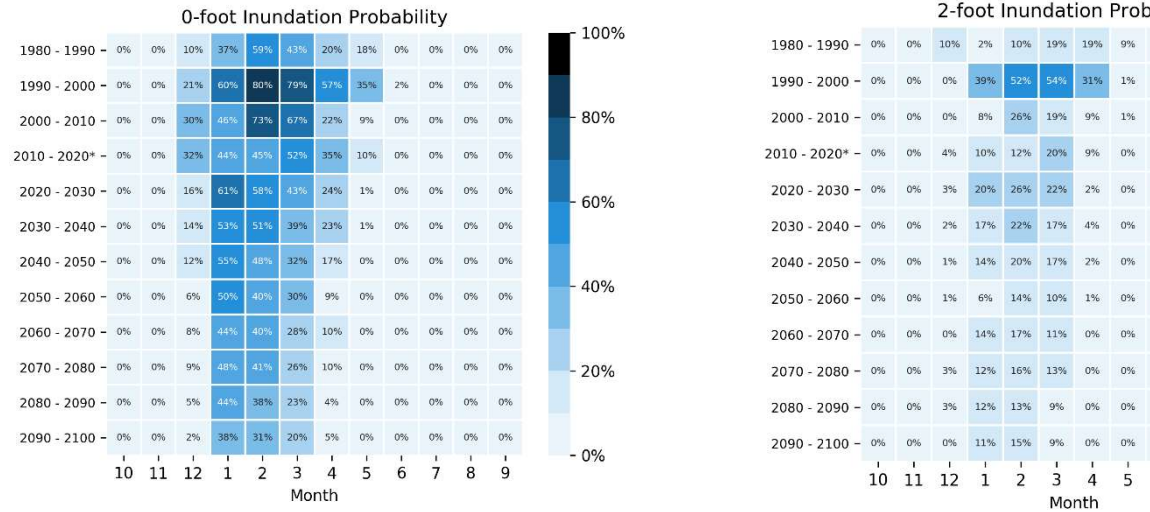
Figure 26. Representative Photo and Modeled Hydrology for Smith Pond

Smith Pond, January 30, 2017 (Balance Hydrologics)

Modeled Inundation under Existing Conditions

A representative photo and the modeled hydrology for Smith Pond are illustrated in Figure 26.

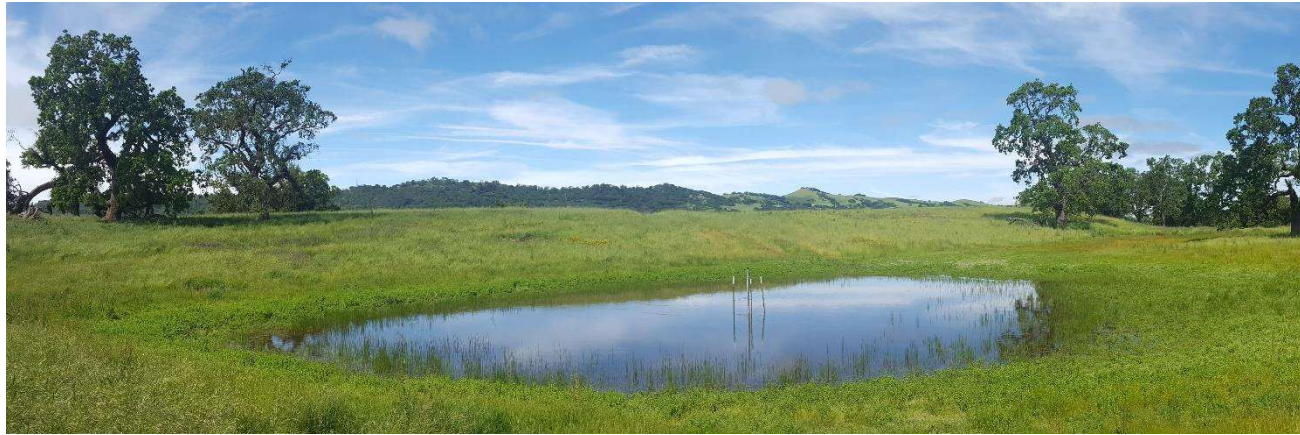
Figure 27. Representative Photo and Modeled Hydrology for Valley Oak

Valley Oak Pond, May 10, 2017 (Balance Hydrologics)

**Modeled
 Inundation
 under
 Existing
 Conditions**

A representative photo and the modeled hydrology for Valley Oak Pond is illustrated in Figure 27.

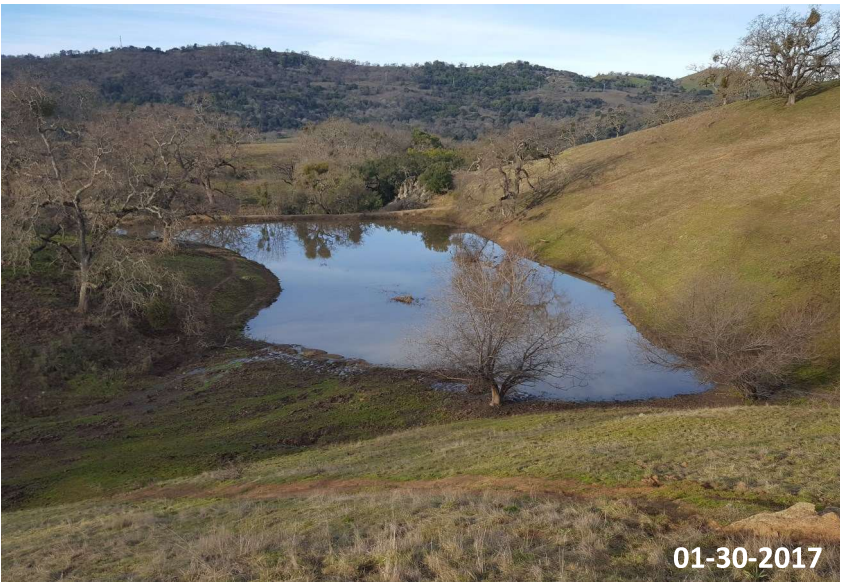
Bass Watershed Characteristics	
Size	111 acres
Geology	Franciscan melange and metamorphic complex
Soils	Los Gatos-Gaviota Complex, gravelly loam
Berm Observations	Channel downstream undermining spillway
Fault	None
Pond Classification	Instream
Preliminary Findings	Never empty, spills most years
Model Limitations

Figure 1a. Bass Lake. Lake characteristics and hydroperiod model results, Joseph D. Grant County Park, Santa Clara County, CA.

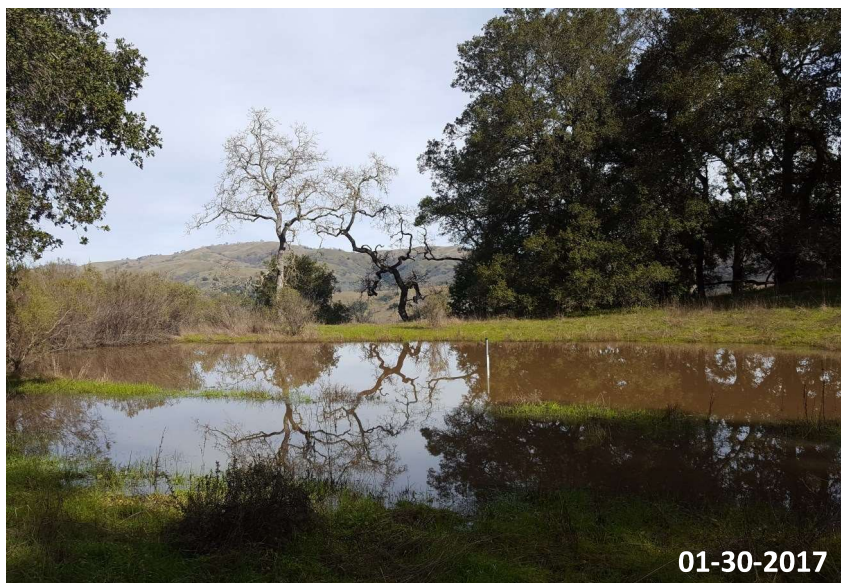
Figure 1b.

Size	1.1 acres
Geology	Miocene sedimentary rocks, Quaternary hillslope deposits
Soils	Los Gatos-Gaviota Complex, gravelly loam
Berm Observations	No Berm
Fault	None
Pond Classification	Tectogenic
Preliminary Findings	Dries up annually, frequently dry year-round
Model Limitations	Model may over-predict peaks

Brush Pond. Pond characteristics and hydroperiod model results, Joseph D. Grant County Park, Santa Clara County, CA.

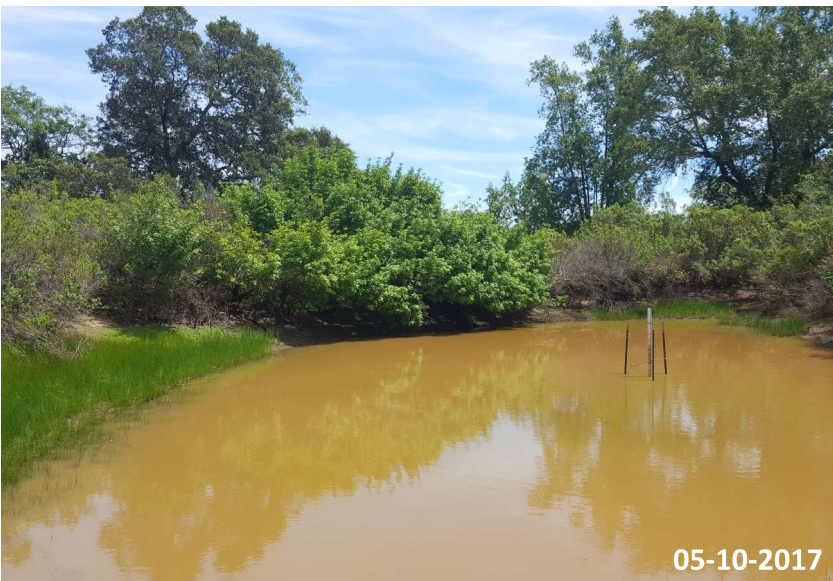
Figure 1c.

Dairy Watershed Characteristics

Size	3.1 acres
Geology	Miocene sedimentary rocks, Quaternary hillslope deposits
Soils	Los Gatos-Gaviota Complex, gravelly loam
Berm Observations	Appears to be in good condition, no incision observed
Fault	None
Pond Classification	Tectogenic
Preliminary Findings	Dries up annually, ponding every year for at least one month
Model Limitations	Model may over-predict largest peaks, and under-predict smaller peaks (existing clay layer in bottom 1-foot of pond not explicitly modeled)

Dairy Pond. Pond characteristics and hydroperiod model results, Joseph D. Grant County Park, Santa Clara County, CA.

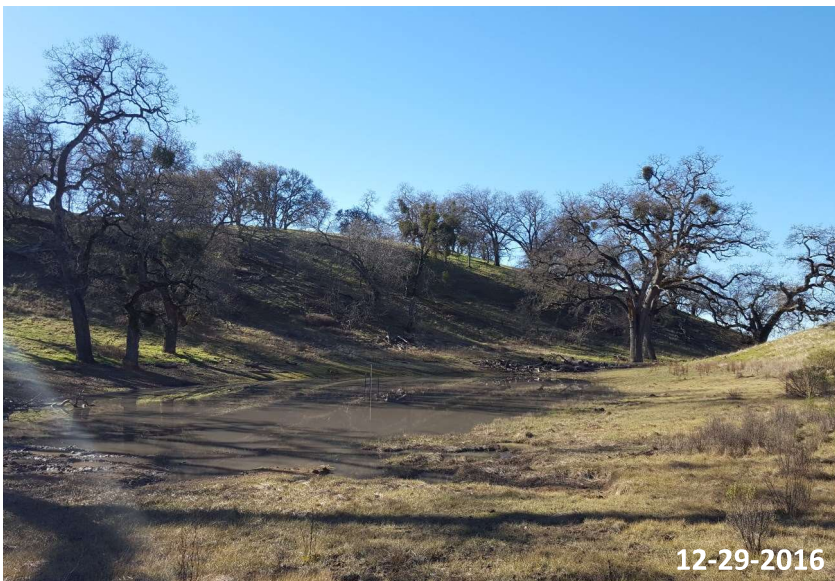
Figure 1d.

Deer Valley Watershed Characteristics	
Size	7.7 acres
Geology	Franciscan metamorphic complex
Soils	Los Gatos-Gaviota Complex, gravelly loam
Berm Observations	No Berm
Fault	None
Pond Classification	Instream/Tectogenic
Preliminary Findings	Dries up annually, spills during wet years
Model Limitations	Model may predict more rapid dry down in wet years

Deer Valley Pond. Pond characteristics and hydro-period model results, Joseph D. Grant County Park, Santa Clara County, CA.

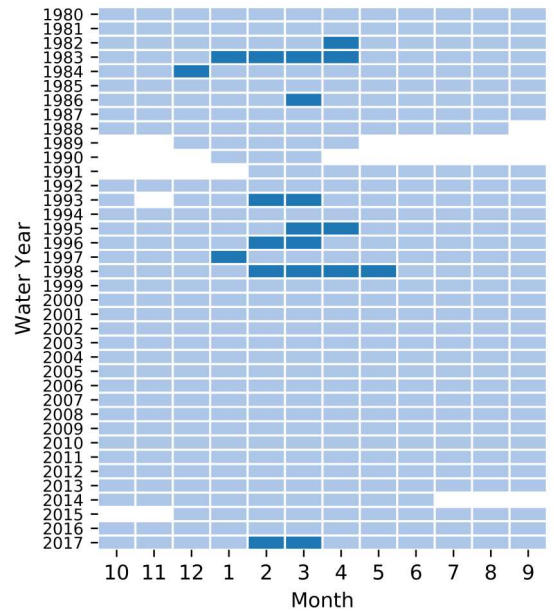
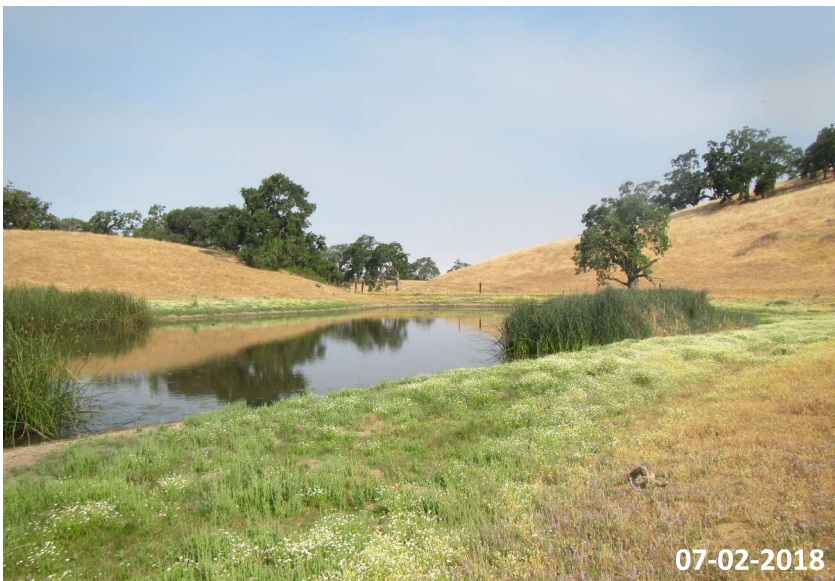
Figure 1e.

Eagle Watershed Characteristics

Size	12.9 acres
Geology	Franciscan melange and meta-morphic complex
Soils	Los Gatos-Gaviota Complex, gravelly loam
Berm Observations	Appears to be in good condition, no incision observed
Fault	None
Pond Classification	Tectogenic
Preliminary Findings	Dries up only in extreme droughts, rarely spilling
Model Limitations

Eagle Pond. Pond characteristics and hydroperiod model results, Joseph D. Grant County Park, Santa Clara County, CA.

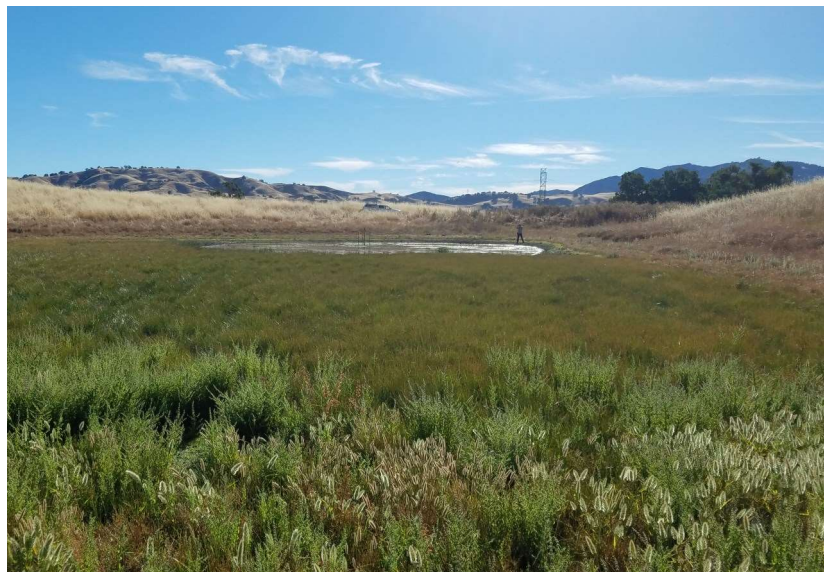
Figure 1f.

Edwards Watershed Characteristics

Size	12.6 acres
Geology	Miocene sedimentary rocks
Soils	Los Gatos-Gaviota Complex, gravelly loam
Berm Observations	Appears to be in good condition, no incision observed
Fault	None
Pond Classification	Tectogenic
Preliminary Findings	Ponding sensitive to droughts and wet periods, pond rarely spills
Model Limitations	Model may over-predict peaks

Edwards Pond. Pond characteristics and hydroperiod model results, Joseph D. Grant County Park, Santa Clara County, CA.

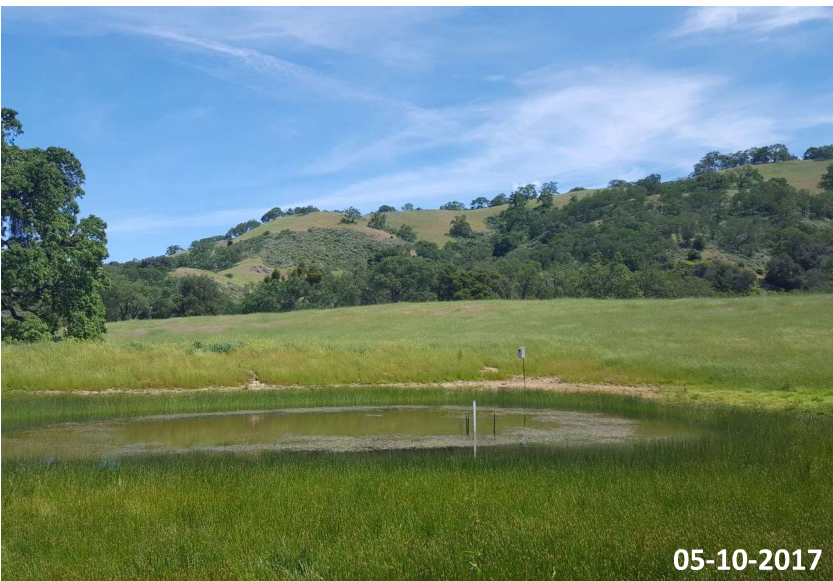
Figure 1g.

Size	3.9 acres
Geology	Franciscan melange and meta-morphic complex
Soils	Los Gatos-Gaviota Complex, gravelly loam
Berm Observations	No Berm
Fault	None
Pond Classification	Tectogenic/Instream
Preliminary Findings	Dries up each year, rarely spills
Model Limitations	Model may over-predict peaks

Hotel Pond. Pond characteristics and hydroperiod model results, Joseph D. Grant County Park, Santa Clara County, CA.

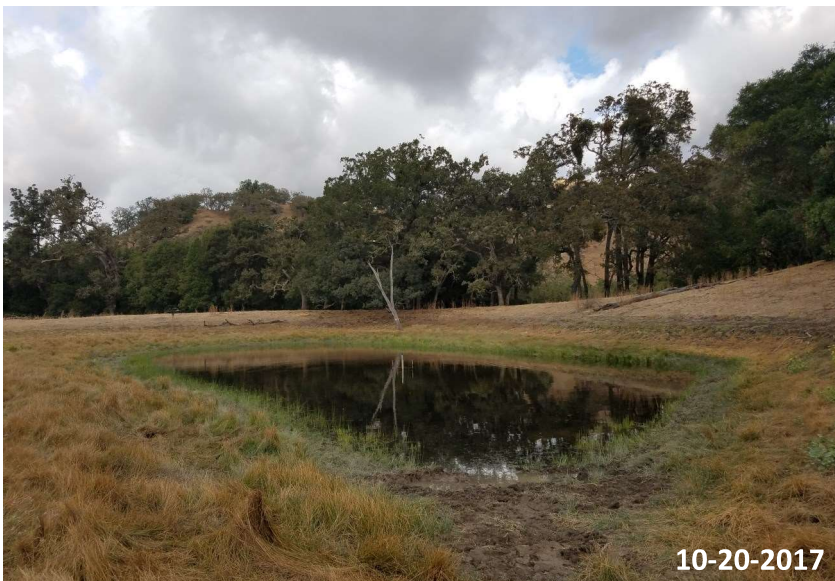
Figure 1h.

Kamera Watershed Characteristics

Size	8.9 acres
Geology	Franciscan melange
Soils	Los Gatos-Gaviota Complex, gravelly loam
Berm Observations	Appears to be in good condition, no incision observed
Fault	None
Pond Classification	Tectogenic
Preliminary Findings	Dries up in about half the years, rarely spills
Model Limitations	Model may over-predict lower water-surface elevations

Kamera Pond. Pond characteristics and hydroperiod model results, Joseph D. Grant County Park, Santa Clara County, CA.

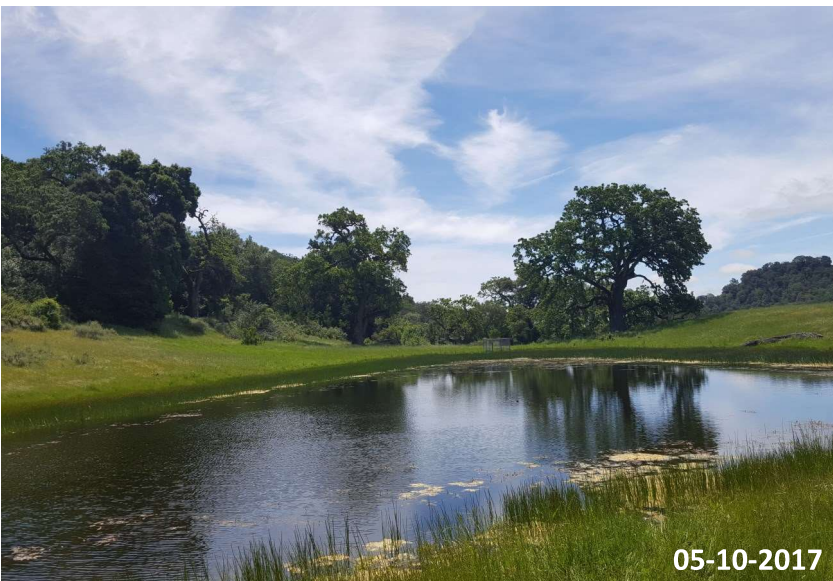
Figure 1i.

Rattlesnake Watershed Characteristics	
Size	8.9 acres
Geology	Franciscan melange and metamorphic complex
Soils	Los Gatos-Gaviota Complex, gravelly loam
Berm Observations	No Berm
Fault	None
Pond Classification	Tectogenic
Preliminary Findings	Dries up in about half the years, rarely spills
Model Limitations	Model may over-predict peaks

Rattlesnake Pond. Pond characteristics and hydro-period model results, Joseph D. Grant County Park, Santa Clara County, CA.

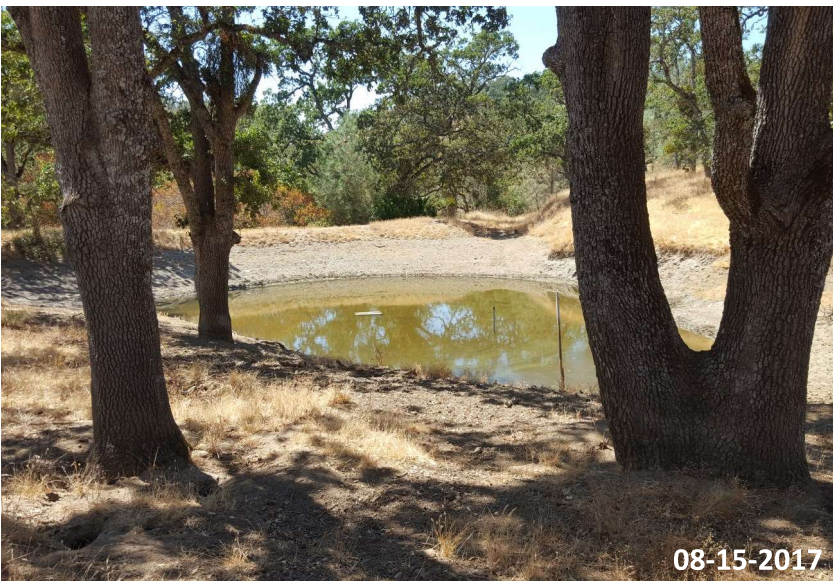
Figure 1k.

Valentine Watershed Characteristics

Size	9.7 acres
Geology	Franciscan metamorphic complex
Soils	Los Gatos-Gaviota Complex, gravelly loam
Berm Observations	Appears to be in good condition, no incision observed
Fault	None
Pond Classification	Instream
Preliminary Findings	Dries up in most years, rarely spills
Model Limitations	Model may under-estimate groundwater inputs during very wet years

Valentine Pond. Pond characteristics and hydro-period model results, Joseph D. Grant County Park, Santa Clara County, CA.

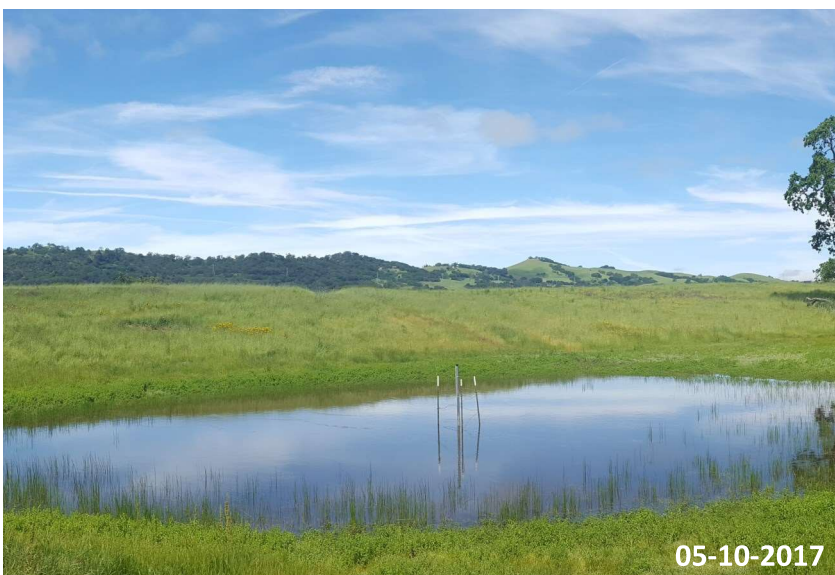
Figure 11.

Valley Oak Watershed Characteristics	
Size	4.8 acres
Geology	Quaternary hillslope deposits
Soils	Los Gatos-Gaviota Complex, gravelly loam
Berm Observations	Appears to be in good condition, no incision observed
Fault	None
Pond Classification	Landslide Headscarp/Instream
Preliminary Findings	Dries up annually, rarely spills, if ever
Model Limitations	Model may over-predict peaks

Valley Oak Vernal Pool. Vernal pool characteristics and hydroperiod model results, Joseph D. Grant County Park, Santa Clara County, CA.

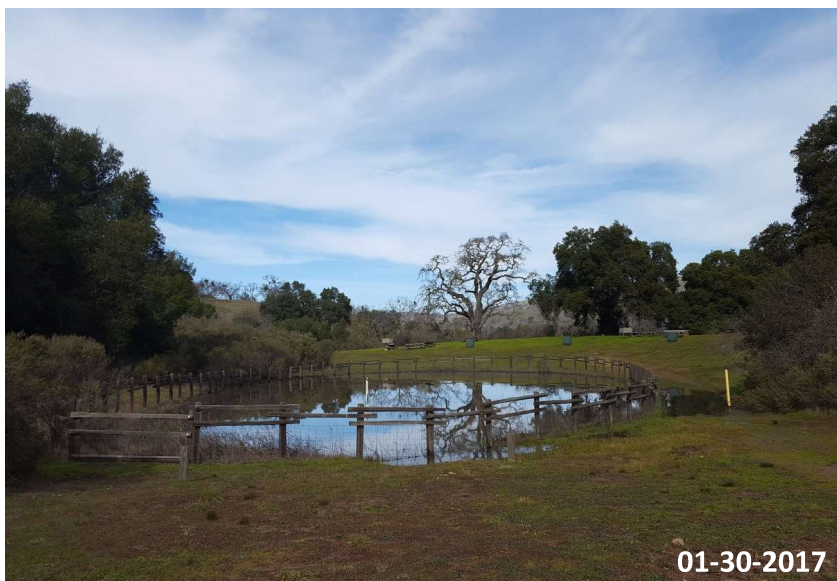
Woodland Watershed Characteristics	
Size	4.6 acres
Geology	Miocene sedimentary rocks, Quaternary hillslope deposits
Soils	Los Gatos-Gaviota Complex, gravelly loam
Berm Observations	No Berm
Fault	None
Pond Classification	Tectogenic
Preliminary Findings	Dries up annually, rarely spills, if ever
Model Limitations	Model may over-predict peaks

Figure 1m. Woodland Pond. Pond characteristics and hydro-period model results, Joseph D. Grant County Park, Santa Clara County, CA.
