Water Year 2025 ◦ JULY 2026

# FINAL Mitigation Monitoring Report for the Downtown and Upper Guadalupe River Flood and Aquatic Habitat Improvement Projects, San Jose and Santa Clara, California

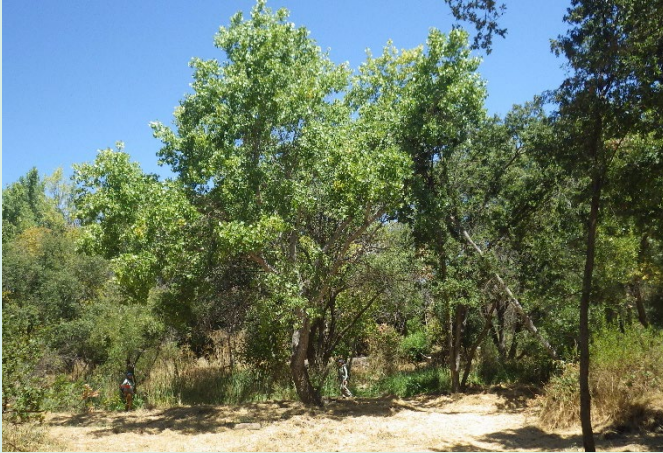
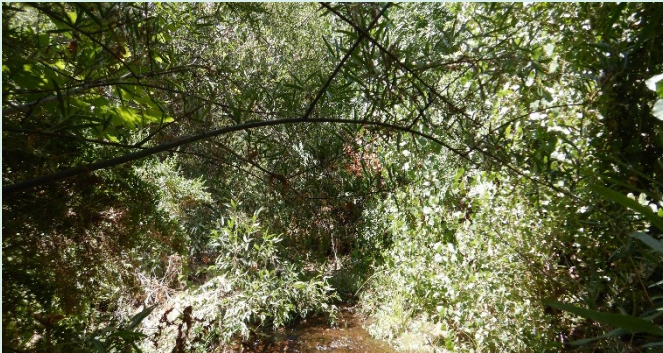
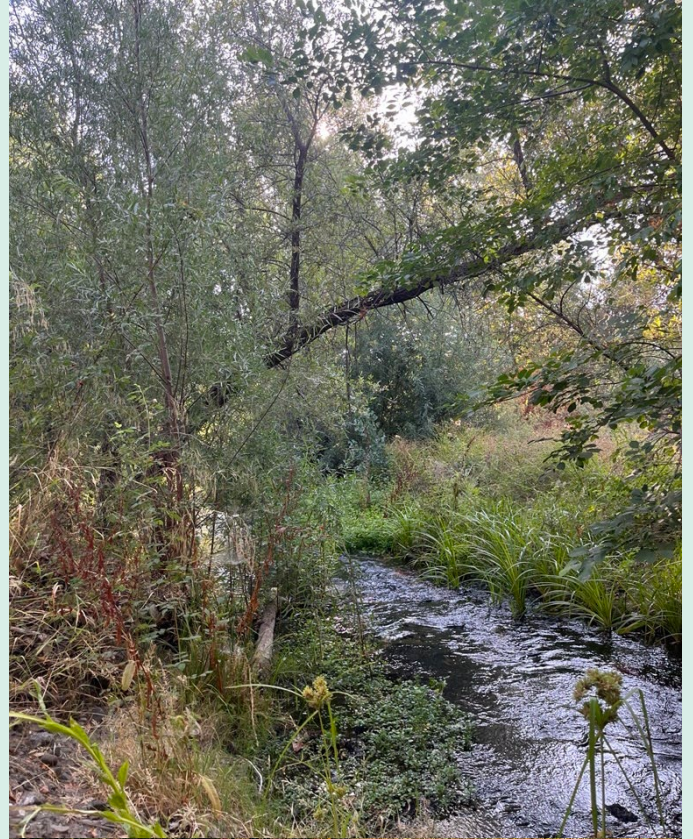
Cover photos: Photographs of WY 2025 conditions in the Guadalupe River Downtown Project's mitigation areas (Segment 1 and Guadalupe Creek).
